# EAGLE COUNTY REGIONAL AIRPORT MASTER PLAN

## Appendix B

## **B TERMINAL AREA STUDY**

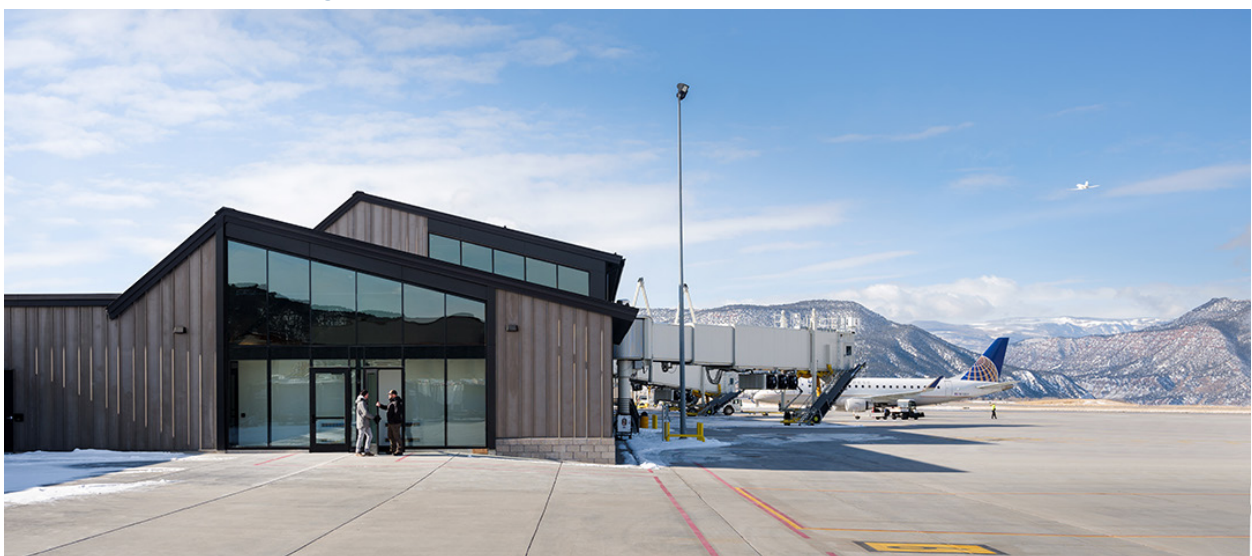
Figure B-7 – Concourse Exterior

Currently the two main massing elements for the terminal are the original terminal, built in 1996, and the recently completed Concourse Renovation project in 2019. For the purposes of this inventory, they will be discussed separately.

The new concourse included significant improvements to the building envelope and the performance of the overall building from an energy code standpoint. The new steel structure had a building envelope assembly attached which included continuous insulation, air and water barriers, bonderized metal cladding, standing seam metal panel roof & large portions of high-performance curtainwall glazing. On the interior the primary elements included wood plank dropped ceiling and poured concrete slab flooring system with carpet in select areas.

The original terminal is a heavy timber structure, including exposed glulam beams, columns and wood decking. The insulation was mostly captured between studs, rather than run continuously, which has led to thermal inadequacies. Stucco cladding with a standing seam metal panel roof covers a majority of the building envelope. The glazing throughout is punched openings with a storefront glazing system. Flooring throughout is carpet with ceramic tile in select areas.

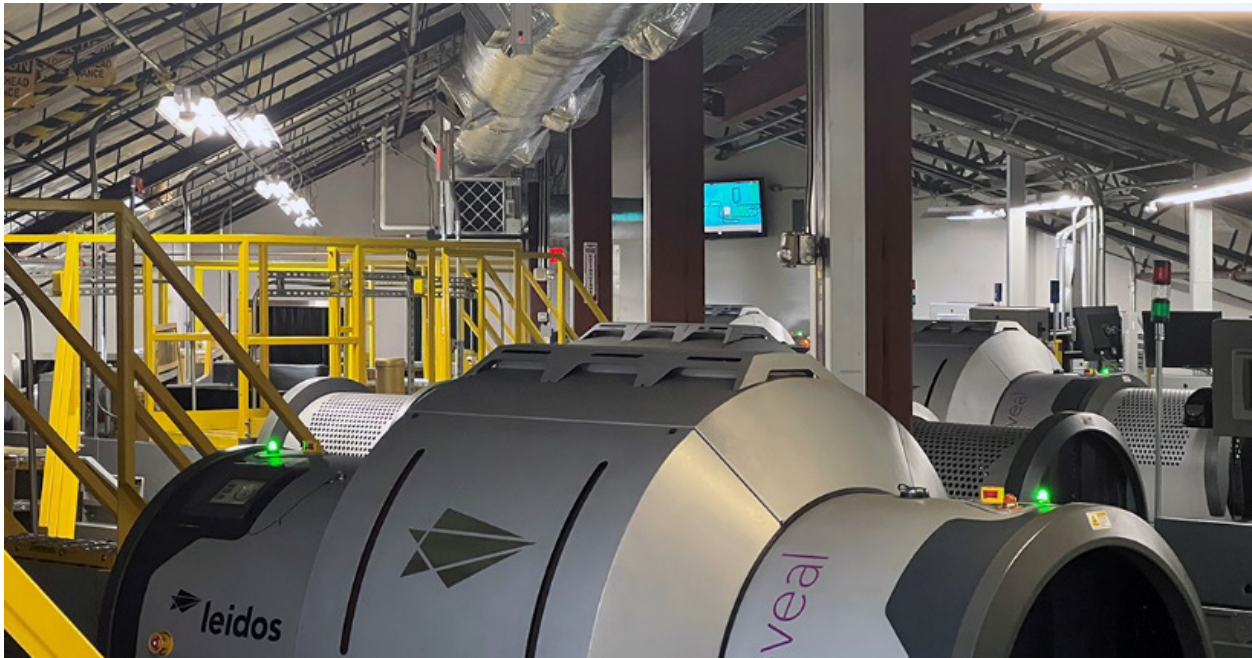
**Figure B-9B – Screening**

BNP Associates, Inc. was retained by the Eagle County Air Terminal Corporation (ECAT) to design an outbound inline checked baggage inspection systems (CBIS) capable of screening skis. The baggage system’s design consists of two EDS screening pods, each of which contains three EDS machines. The pods are fed by three ticket counters and two curbside lines. The EDS pods divert ski bags to either a CT80DRXL line or to the out-of-gauge line for screening and standard passenger bags to CT80DR machines. In case of an EDS machine failure, the system has a purge functionality. Out-of-gauge bags are diverted around the EDS devices onto an OG line for transport to ETD screening. BNP’s designs incorporate the latest TSA Planning Guidelines & Design Standards making the EGE baggage handling system design fully compliant to TSA’s current protocol for 100% inline certified EDS checked baggage screening.

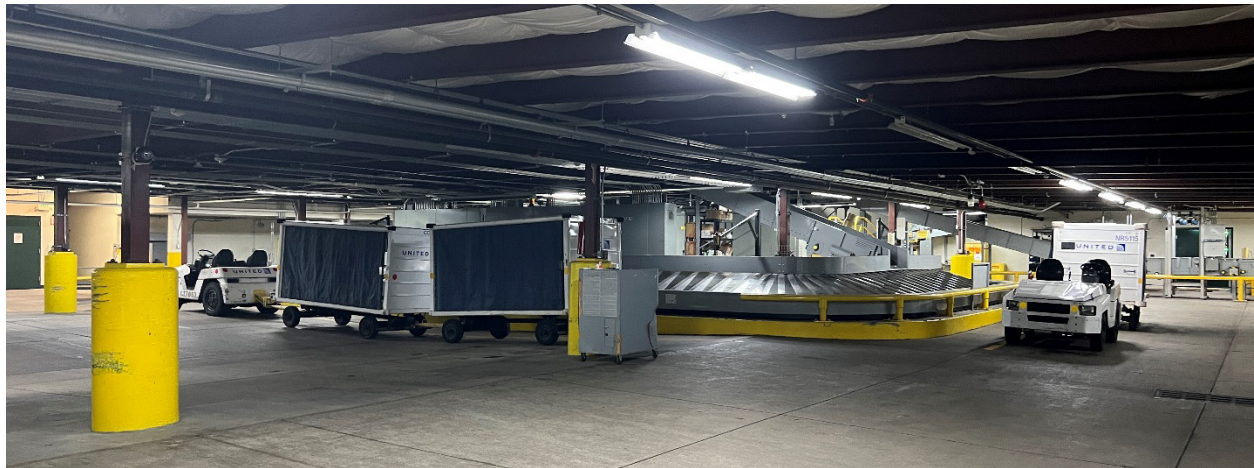
**Figure B-10A – Baggage Makeup**

In fall of 2009 the terminal lobby equipment was removed and upgraded to include four (4) Reveal CT80-DR's machines and two (2) Reveal CT80-XL machine.

Many elements were carefully considered while constructing the in-line operations mezzanine, including locating the mezzanine in the best possible area for bag movement and conveyor installation, use of existing conveyor systems, and structural reinforcement to carry the loads of the heavy in-line equipment and screening operations. It was envisioned that the conveyors currently delivering bags for all airlines will all be routed to the in-line bag screening area on the mezzanine and sorted to the appropriate airline belt once screened. The local TSA collected baggage and passenger information which has been used in the assumptions for the inline screening analysis to determine screening demands for an in-line system to meet current demand needs and DBU + 5 years.

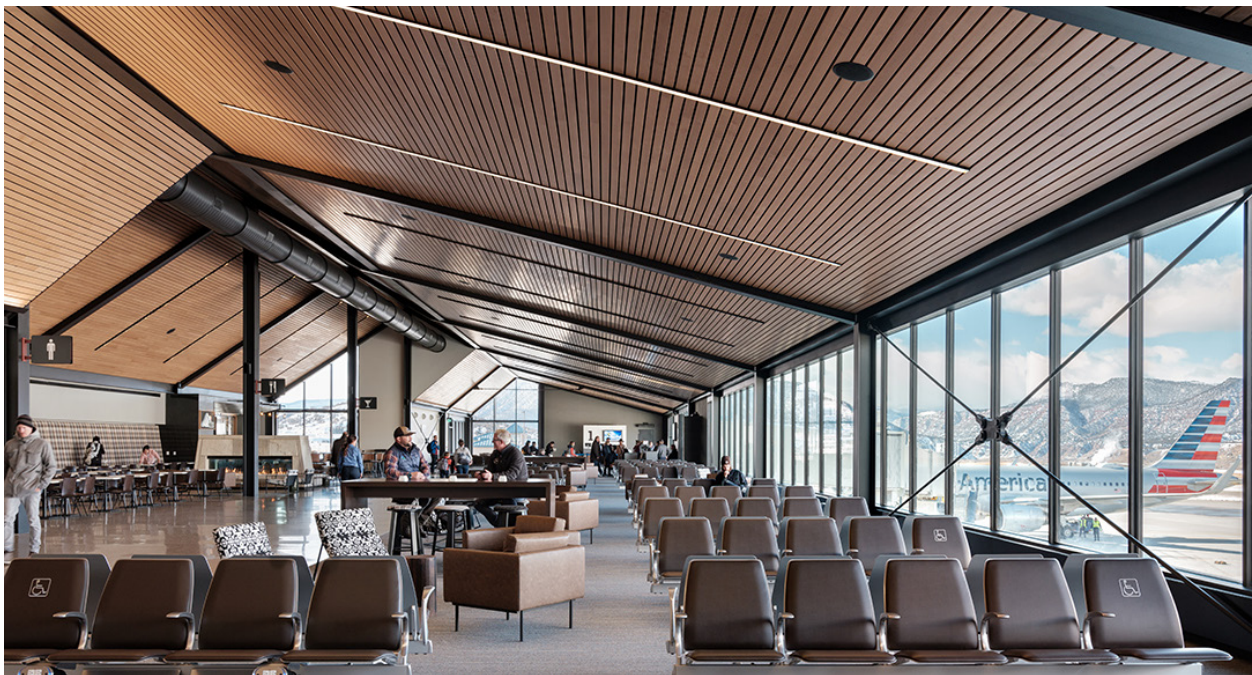
**Figure B-12 – Level 02 Holdrooms**

The terminal has 16,000 square feet of holdroom area reserved for scheduled outgoing passengers waiting to access their aircraft through one of the 6 available gates. The concourse has 6 gates total, four on level 2 with passenger boarding bridges (PBB) and two ground loaded gates on level 1. The holdrooms have a mix of tandem seating, lounge seating, and tables to meet the varied needs of the passengers. The majority of the holdroom layouts exist within a 27-foot depth and adjacent to a 20-foot concourse circulation path and there is increased density of holdrooms on both the east and west ends of the concourse. The compression of the roof form at the gate lounges creates a more intimate environment and strong connection with the airfield and landscape beyond. Holdroom 1, on the west end of level 2, has a 78' boarding bridge extender to the west. Holdrooms 5 and 6 are the ground loading gates on level 1, and passengers egress out the east vestibule to the apron.
